## CHAPTER 9

### ATTENDANT'S CONSOLE AND ATC INTERFACE GROUP

This chapter provides a functional description of the attendant's console (ATC) and its interface group.

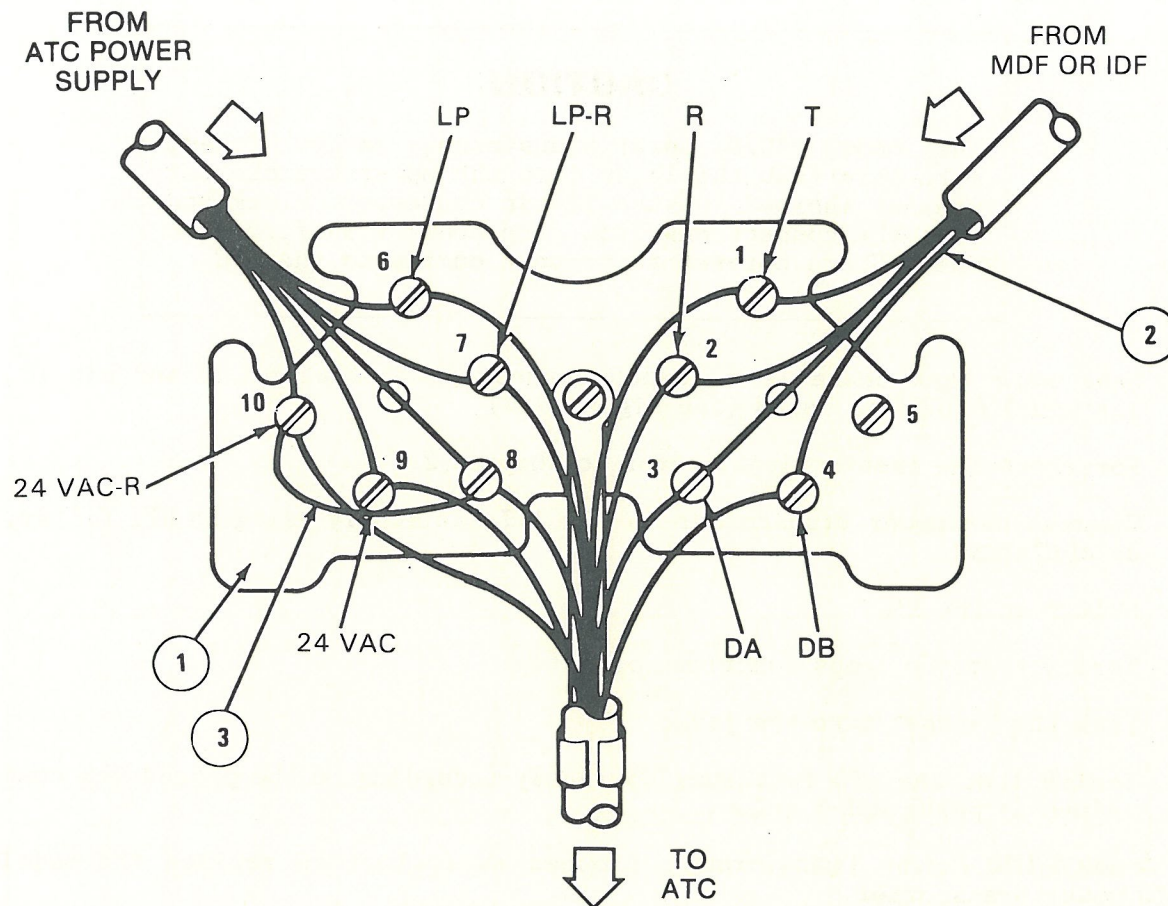
82A0461

TERMINAL NO.	FROM MDF OR IDF	FROM ATC POWER SUPPLY	ATC LINE CORD CONNECTIONS	FUNCTION
1	WHT/BLU	NOT USED	WHT/BLU	TIP
2	BLU/WHT	NOT USED	BLU/WHT	RING
3	WHT/ORN	NOT USED	WHT/ORN	DATA A
4	ORN/WHT	NOT USED	ORN/WHT	DATA B
5	NOT USED	NOT USED	NOT USED	NOT USED
6	NOT USED	BRN/WHT	BRN/WHT	LAMP POWER
7	NOT USED	WHT/BRN	WHT/BRN	LAMP POWER RETURN
8	NOT USED	WHT/SLT	WHT/SLT	GROUND
9	NOT USED	GRN/WHT	GRN/WHT	24 VAC
10	NOT USED	WHT/GRN	WHT/GRN	24 VAC RETURN

Figure 9-3. ATC Connector Block

1. Switch off the ATC and disconnect the power transformer from the 117-Vac supply.
2. Disconnect the handset from the console.
3. Disconnect the ATC from the 10-pin connector block (Figure 9-3).
4. Assemble the replacement ATC. (Refer to paragraph 2.6.1, ATC Installation.)
5. Connect the replacement ATC to the 10-pin connector block. (See Figure 9-3 for color coding and connections.)

1. Switch off the ATC.
  2. Disconnect the power transformer from the 117-Vac supply.
  3. Disconnect the power transformer from the 10-pin connector block (Figure 9-3).

4. Connect the cable on the replacement transformer to the 10-pin connector block. (See Figure 9-3 for color coding and connections.)
  5. Make sure that there is a jumper connection between pin 8 and pin 10.

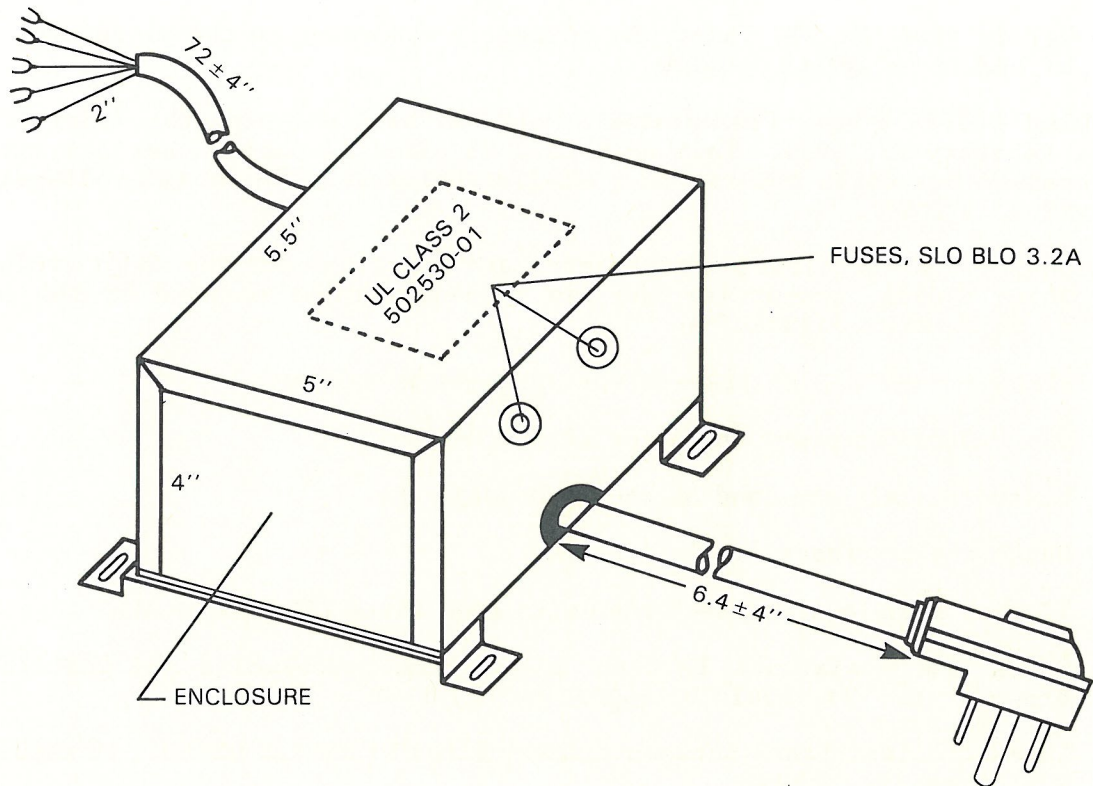
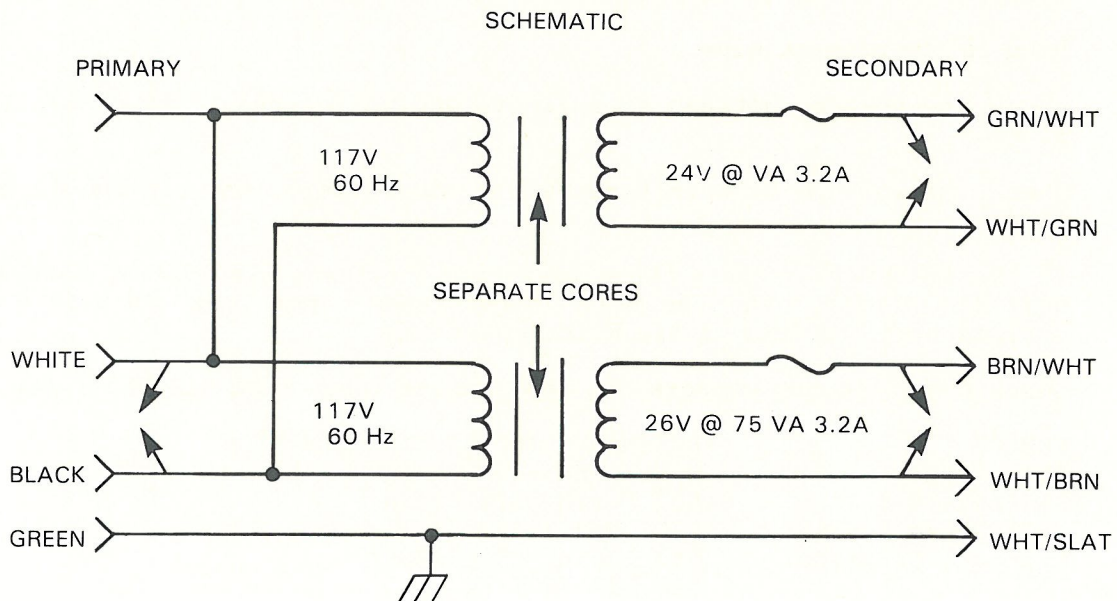
82A0462

Figure 9-4. ATC Power Transformer (Model 87070A)

6. Make sure that there is a jumper connection between pin 8 and pin 10. The model 87070A is fused (see Figure 9-4).
  7. For grounding instructions, refer to Chapter 2.

Maintenance and installation techniques are identical for the model 87070 and the model 87070A, except for the two secondary fuses mounted on the model 87070A, as shown in Figure 9-4.

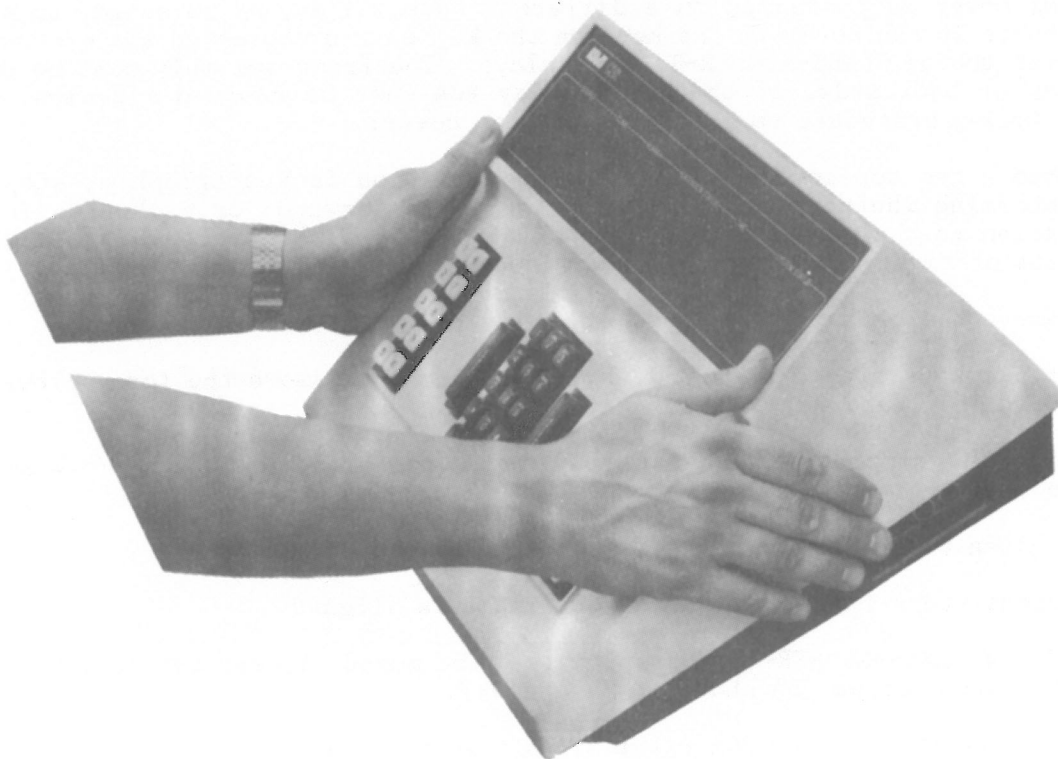
Illig 12492-1

Figure 9-6. ATC Top Cover Removal

1. Switch off the ATC.
2. Unscrew the top cover latching screw until the latching mechanism releases (Figure 9-5).
3. Face the console from the normal operating position and grasp the top on each side as shown in Figure 9-6.
4. Rotate the top about its front edge until it clears the back row of keys and there is resistance to further rotation.
5. Pull on the cover so that the front edge moves down and towards you; this disengages the cover from the front lip of the base.
6. When reinstalling the top cover, reverse steps 1 to 4. First, hook the front of the cover under the lip of the base, then lower the cover over the keys.
7. Make sure that the catch along the rear edge of the top cover is seated in the slots on either side of the latching screw before tightening the screw (Figure 9-5).

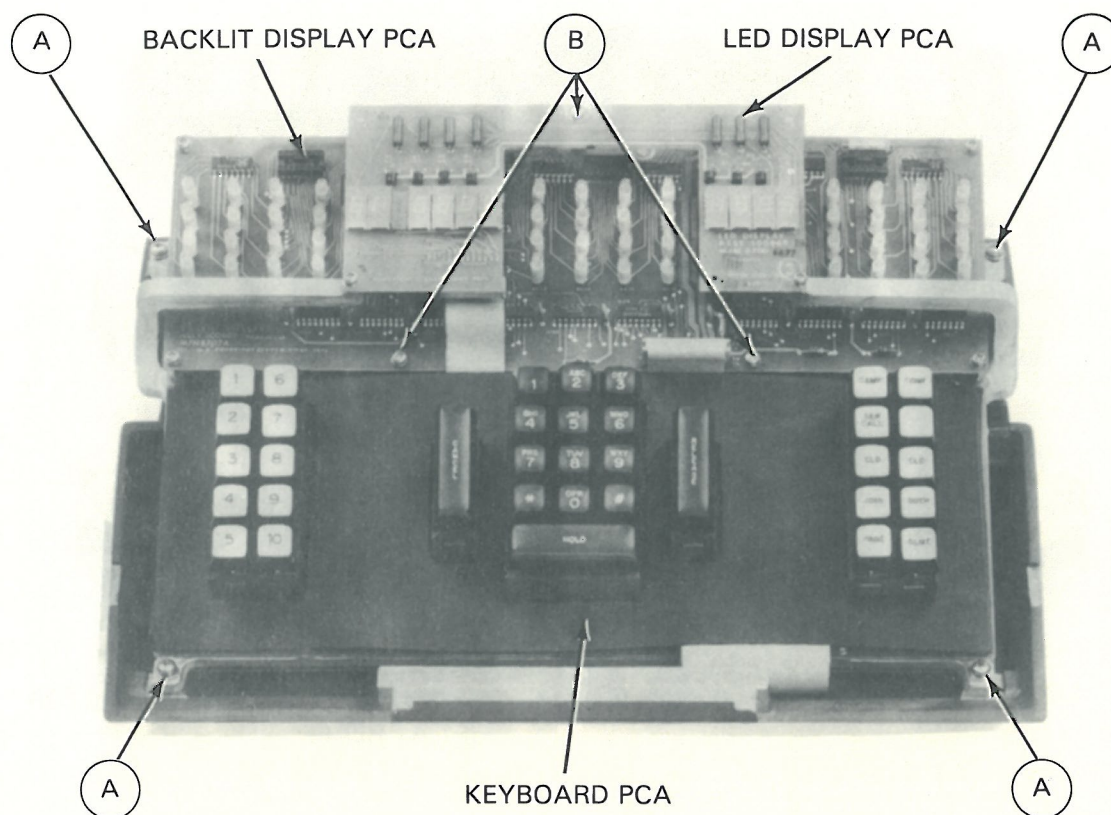
Illig 12492-4

Figure 9-7. ATC Alignment Screws

1. When a new top cover is lowered into position (subparagraph e, step 6), determine whether the keys are to be moved forwards or backwards in relation to the cutouts and/or the CLASS-NUMBER-TIME display is to be moved left or right in relation to the windows.
2. Remove the top cover.
3. If the keys are to be moved, loosen but do not remove the four screws (A) shown in Figure 9-7.
4. Move the complete frame assembly backwards or forwards slightly as required.
5. Tighten the four screws.
6. Repeat steps 1 through 5 until the frame is aligned.
7. If the CLASS-NUMBER-TIME display is to be moved, loosen but do not remove the three screws (B) shown in Figure 9-7.
8. Move the LED display PCA right or left as required.

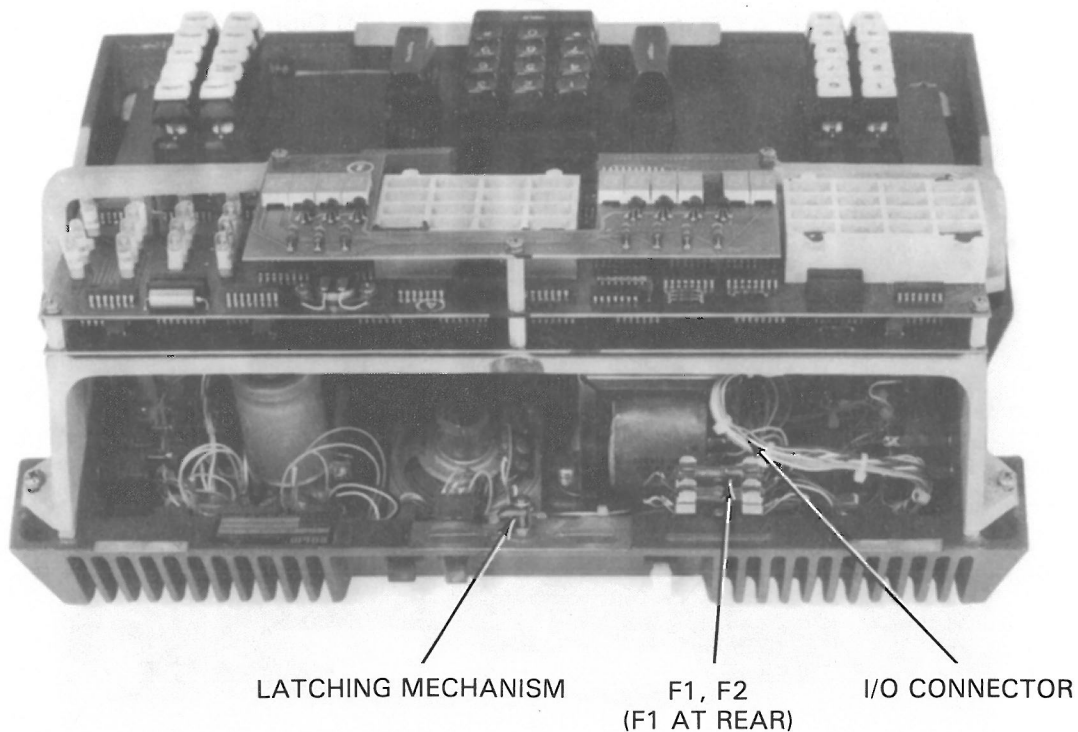
Coluzzi 345-1

Figure 9-8. ATC Fuses

9. Tighten the three screws.
  10. Repeat step 1 and steps 7 through 9 until the display is aligned.
  11. Tighten the cop cover latching screw when the cover is finally replaced.
- g. Fuse Replacement. Proceed as follows to replace fuses:
1. Switch off the ATC.
  2. Remove the top cover.
  3. Identify the blown fuse (F1 or F2) (Figure 9-8).
  4. Replace the blown fuse with a fuse of the correct value:
    - F1: 3A, SB
    - F2: 3A, FB
  5. Reinstall the top cover.
  6. Switch on the ATC.
  7. Verify its operation according to the procedures contained in paragraph i below

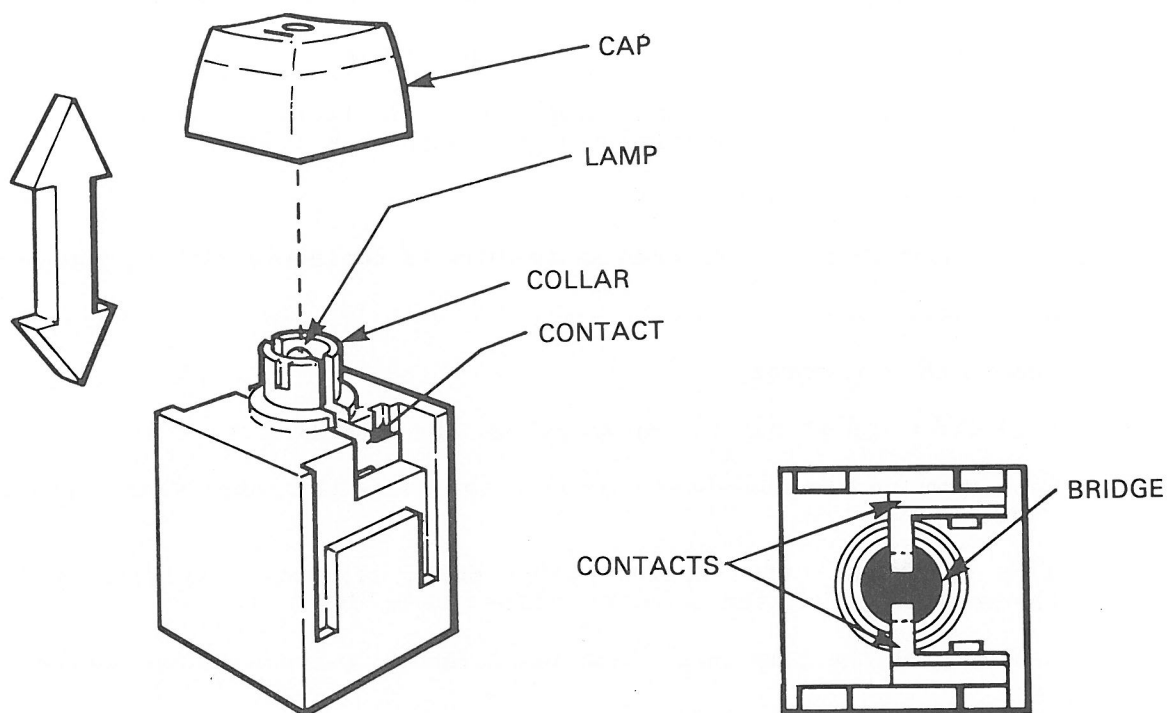
82A0463

Figure 9-9. ATC Push Button Lamp

1. Switch off power.
2. Remove the top cover.
3. Pull off the push button cap to reveal the lamp (Figure 9-9).
4. Push down on the push button collar to expose the lamp, then withdraw the lamp.
5. With the push button collar pushed down, align the replacement lamp to the socket so that the leads straddle the bridge.
6. Gently push the lamp into place and release the push button collar.
7. Reinstall the push button cap.
8. Reinstall, but do not tighten down, the top cover.
9. Switch on power.
10. Wait for the ATC NITE or green indicator to light.
11. Perform the lamp test. If the new lamp does not light or if the NITE or green indicators do not light (red indicator remains on), refer to the troubleshooting procedures in this chapter.
12. Tighten down the top cover.
